Manhole Inspection Summary

Manhole # S15II2007MH

Insp Date: **7/5/06 3:41 PM**

Location Address: **1810 KENWAY RD**

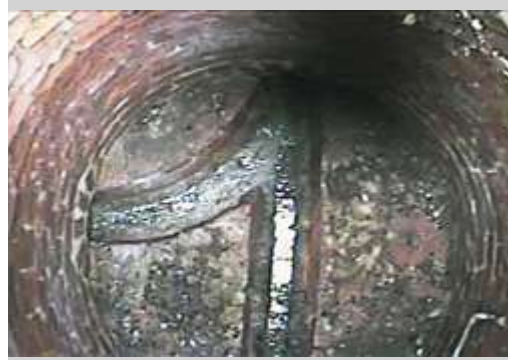
Top View

Corroded steps. Evidence of surcharge - Bench debris.

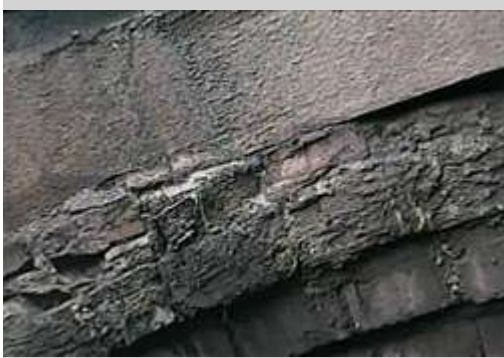
Defect

☒ **Leaks**

Condition: ☐ Sound ☐ Cracked ☐ Root Intrusion ☐ Loose Brick ☒ **Deteriorated**

Infiltration: ☐ None ☒ **Joint** ☐ Cracks ☒ **Mortar** ☐ Roots ☐ Wall

Infiltration: ☐ None ☐ Joint ☐ Cracks ☒ **Mortar** ☐ Roots ☒ **Wall**

Frame leaks. Adjustment deterioration and infiltration. Corbel infiltration.

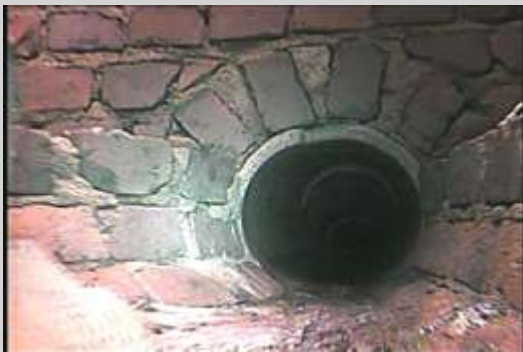
8 in. Circular Gravity Sewer Pipe Out @ 12 O'Clock

Infiltration: **None** Pipe Seal Cond: **Broken**

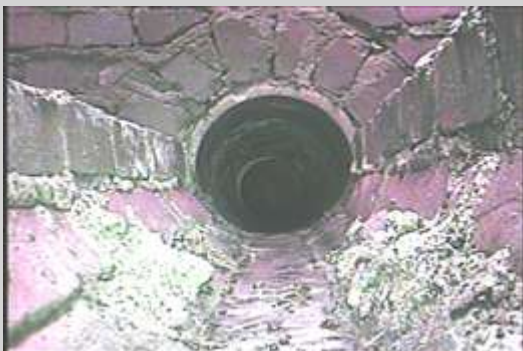
8 in. Circular Gravity Sewer Pipe In @ 6 O'Clock

Barrel deterioration and infiltration. Channel deterioration.

Infiltration: **Evidence** Pipe Seal Cond: **Cracked**

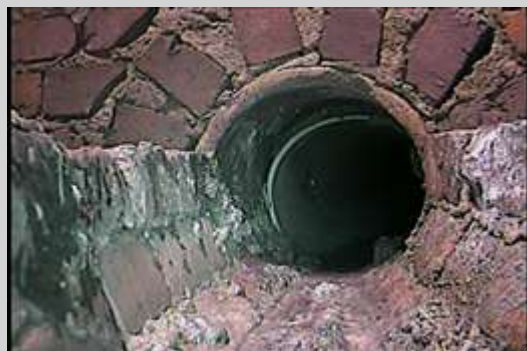
Pipe In @ 9 O'Clock

Deposits: ☐ None ☐ Mud ☐ Sludge ☐ Debris ☒ **Grease**

Deposits Extent: **Light**

Pipe Seal Cond: **Broken**
